# UNDERWATER BRIDGE INSPECTION REPORT

STRUCTURE NO. 6611

MINNESOTA RIVER

MINNESOTA DEPARTMENT OF TRANSPORTATION  
UNDERWATER BRIDGE INSPECTION

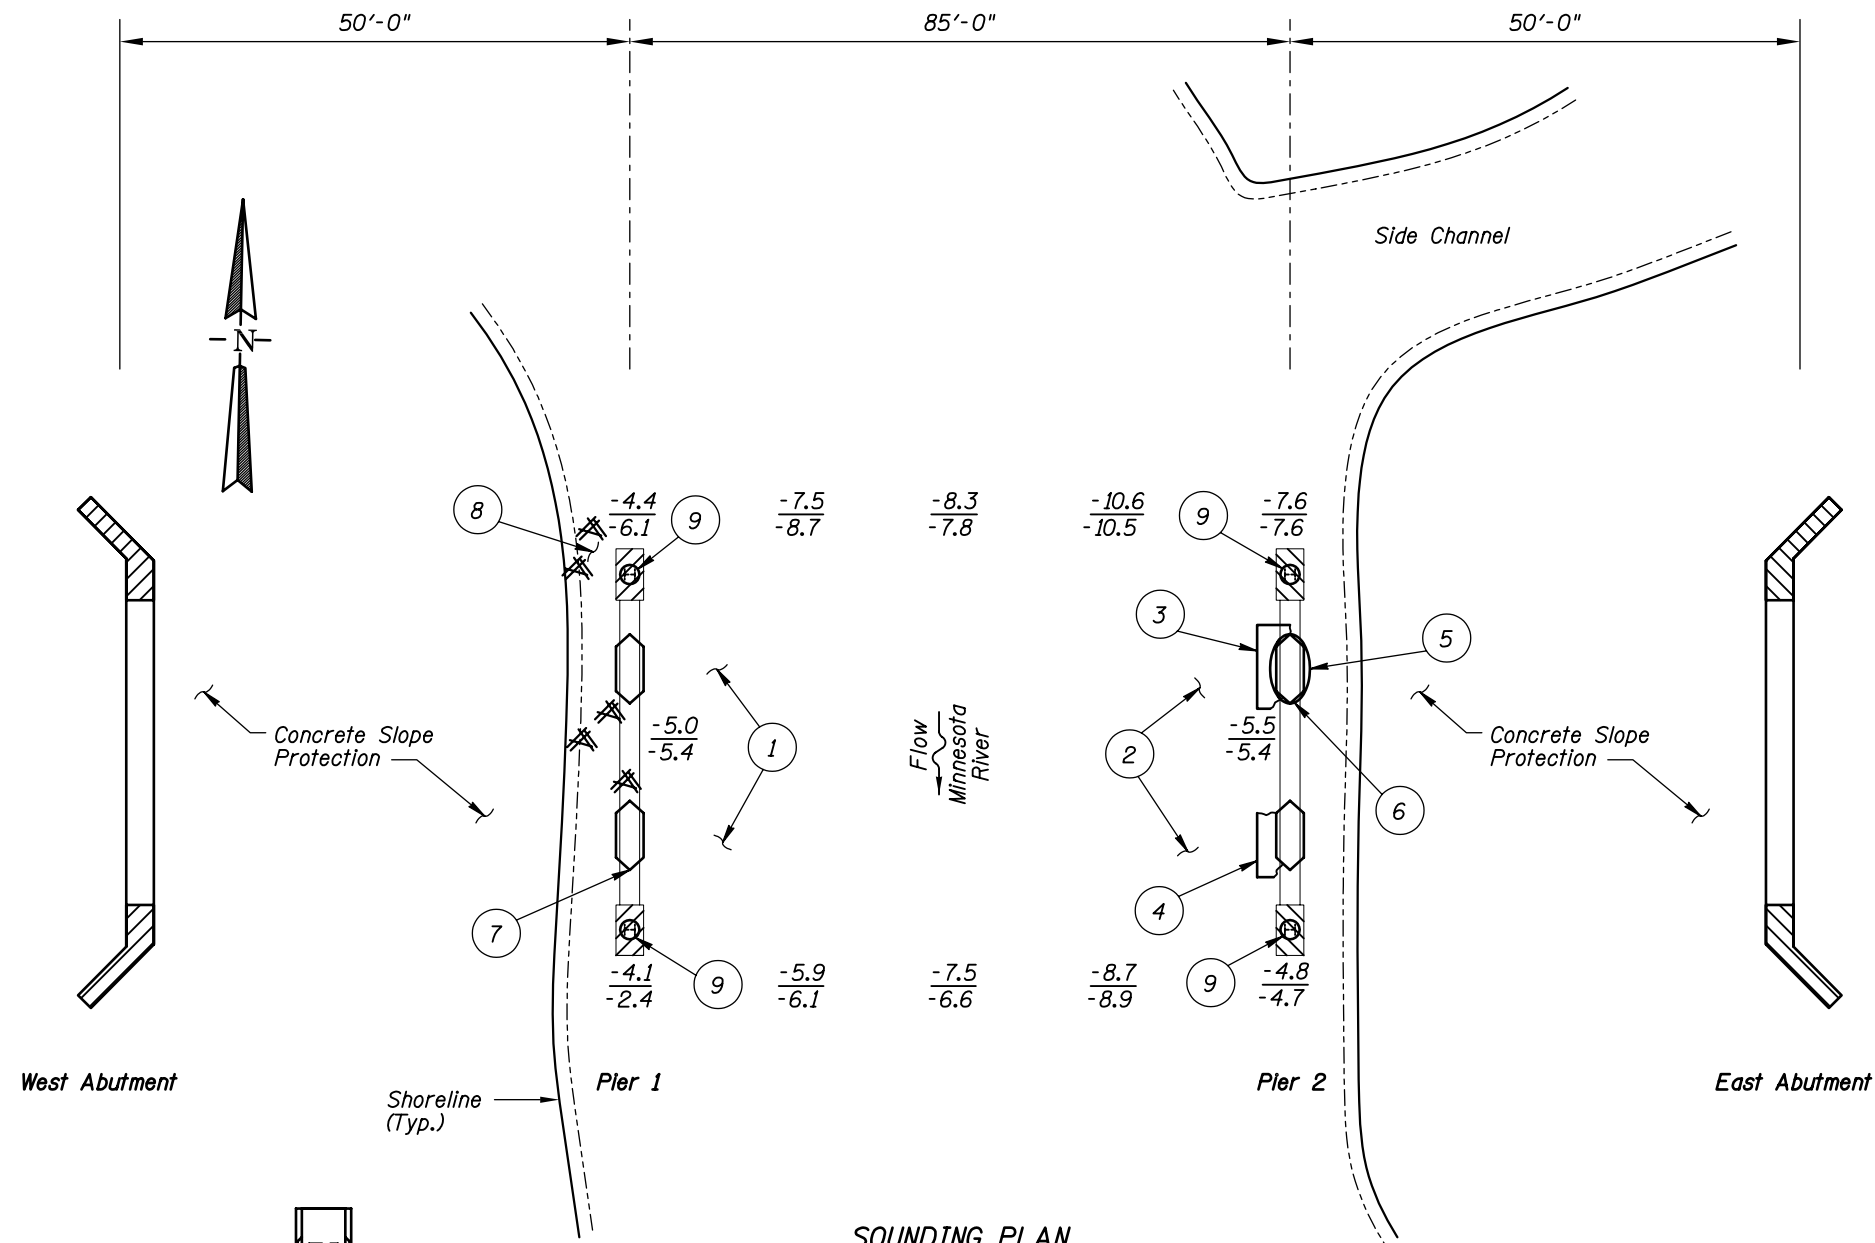
#### INSPECTION AND SOUNDING PLAN

- The channel bottom consisted silty organic material with 4 inches of probe rod penetration.
- The channel bottom consisted of sand and riprap with up to 1 foot in diameter.

- The footing was exposed along the upstream concrete column of Pier 2 with 2 feet of vertical face exposure.
- The footing was exposed along the downstream concrete column of Pier 2 with 10 inches of vertical face exposure.

- The upstream concrete column was encased in steel sheeting that extended from the top of the footing to 2 inches above the waterline. Light corrosion was observed on 100 percent of the surface area of the steel sheeting.

- A gap in the steel sheeting, up to 1/4 inch wide, extended from the top of the sheeting to 2 feet below the waterline at the south end of the column.

- Minor areas of section loss were observed from the waterline to the channel bottom at the downstream end of the concrete column at Pier 1.
- A moderate accumulation of timber debris, with pieces up to 1 foot in diameter, was observed along Pier 1.

- The steel pipe piles exhibited minor surface corrosion above the waterline.

- (A) Monitor the footing exposure at Pier 2 during future underwater inspections for further vertical face exposure and possible undermining of the footing.

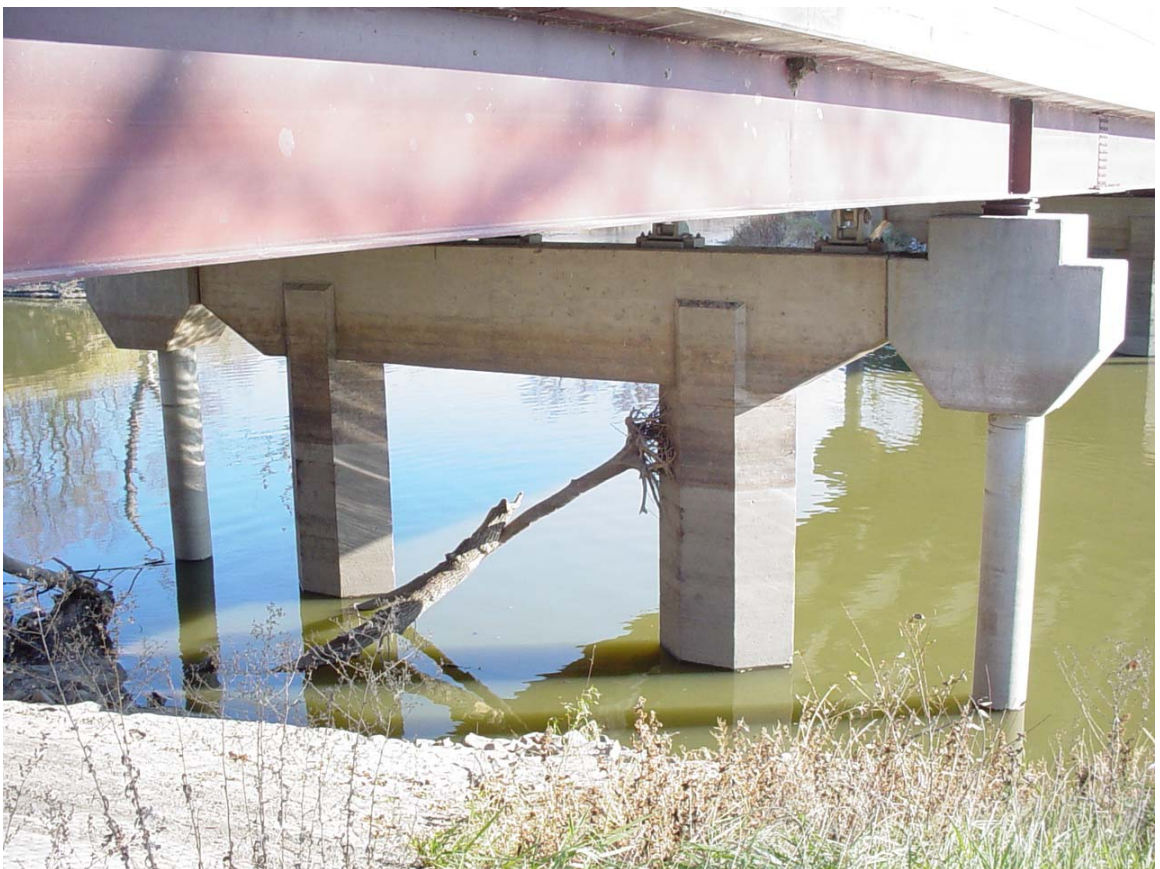
Photograph 2. View of Pier 1, Looking Northeast.

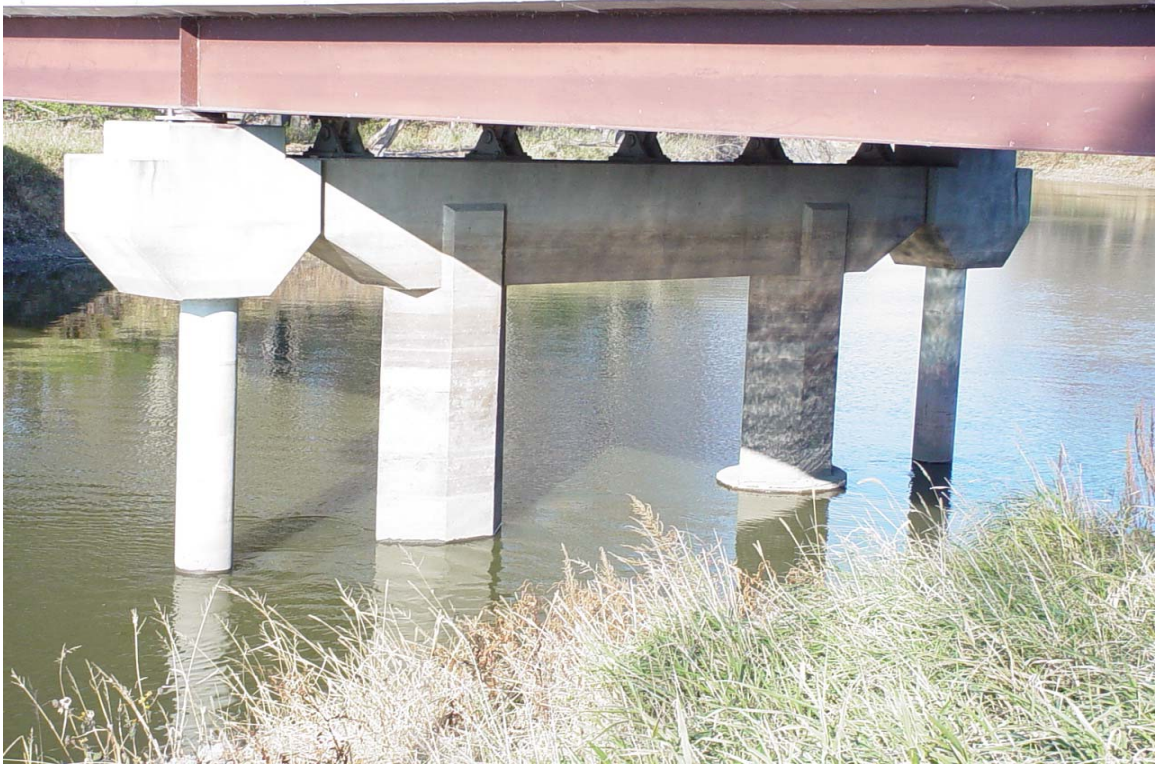
- (A) The footing at Pier 2 was exposed along the east side of the upstream concrete column with 2 feet of vertical face exposure and along east side of the downstream concrete column with 10 inches of vertical face exposure.
- (B) The upstream concrete column at Pier 2 was encased in steel sheeting that extended from the top of the footing to 2 inches above the waterline and exhibited light corrosion over 100 percent of the surface area. A gap in the steel sheeting, up to 1/4 inch wide, was observed at the south end of the column and extended from the top of the sheeting to 2 feet below the waterline.
- (C) A moderate accumulation of timber debris, with pieces up to 1 foot in diameter, was observed along Pier 1.

Photograph 3. View of Pier 2, Looking East.

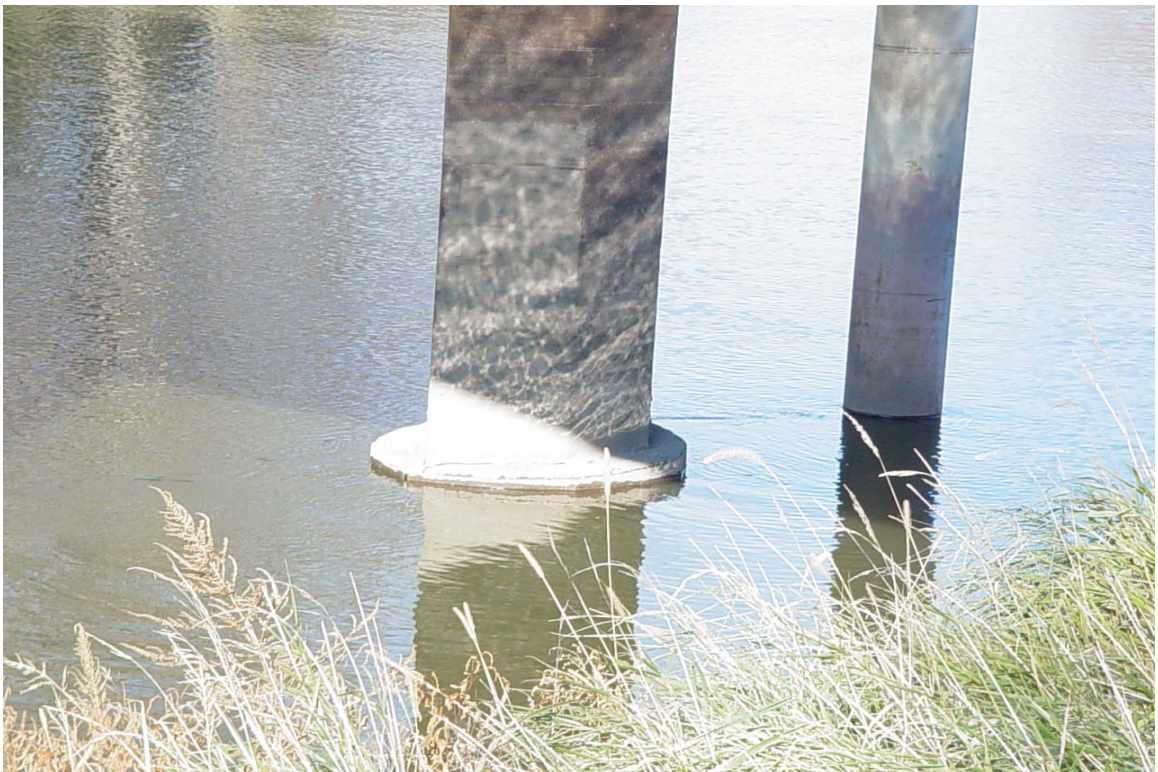
Photograph 4. View of Upstream Column and Pile at Pier 2, Looking Northwest
